Important Product Safety Bulletin Second Notification

Eaton/ Cutler-Hammer General Duty "B" Series Safety Switch

Second Notification of a potential quality issue for General Duty "B" Series Safety Switches that could allow the operating handle to disengage from the mechanism that operates the switch. If this occurs the switch could become jammed in the "On" position with the handle not properly indicating that the switch is in the "On" position while the internal switch is still closed.

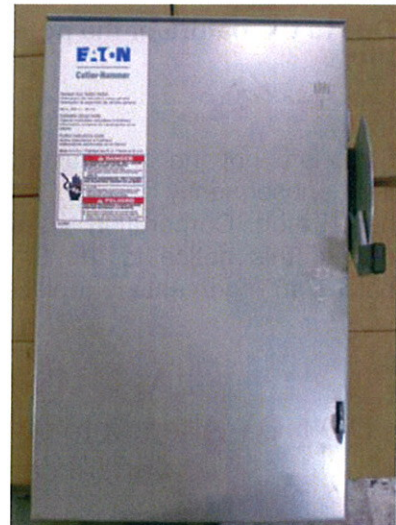
There is the possibility that over time, the operating mechanism could wear in such a way that the switch will no longer function as intended and has the potential of being jammed in the "On" or "Closed" position. The potential also exists that the safety switch handle may indicate it is in the "OFF" position while the internal switch is still closed. Either of these could result in a potentially unsafe condition.

Figure 1: 60A General Duty "B" Series Safety Switch

In order to remedy this potential condition, Eaton Corporation will provide you with a replacement switch at no cost.

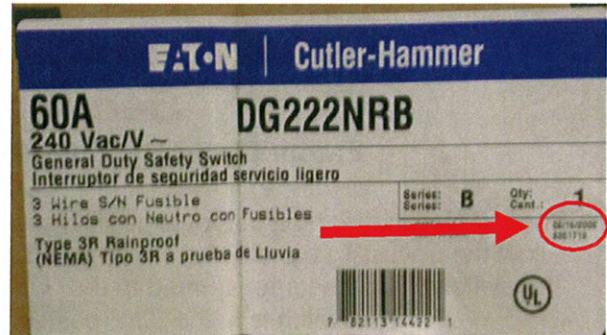
The General Duty "B" Series Safety Switches that were shipped to you with this potential issue were manufactured between 9/17/2009 and 10/12/2009. The date codes for the unit or units in your possession are identified on the labels as shown in Figure 2 and in Figure 3. The date code is located on both the packaging label of the box and on the inside of door of the switch. A list of Suspect Catalog Numbers and the impacted dates for those can be found in Appendix B.

Figure 2: The red circle indicates where the package label date code is located.

To receive the no cost replacement, Eaton Corporation requires that you validate the catalog number of the product that you have received has a date code between or inclusive of the first and last dates noted in Appendix B. Again, the date code can be identified from the carton label (shown in Figure 2) or from the inside door of the unit (shown in Figure 3). If the date code is between or inclusive of the dates shown in Appendix B, then you have a potentially suspect switch which Eaton Corporation will replace.
