Important Product Safety Bulletin First Notification

Eaton/ Cutler-Hammer General Duty “B” Series Safety Switch

First Notification of a potential quality issue for General Duty “B” Series Safety Switches that could allow the operating handle to disengage from the mechanism that operates the switch. If this occurs the switch could become jammed in the “On” position with the handle not properly indicating that the switch is in the “On” position while the internal switch is still closed.

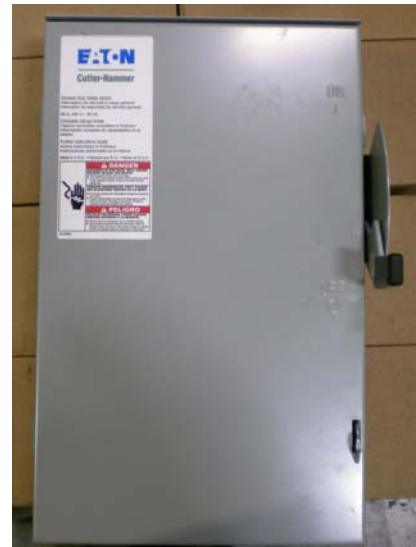
Figure 1: 60A General Duty “B” Series Safety Switch

Our records indicate that Eaton Corporation shipped you a General Duty “B” Series Safety Switch (Figure 1) that is suspected to have a potential safety issue. The issue potentially impacts certain General Duty “B” Series Safety Switches produced between 9/17/2009 and 10/12/2009. Please read through this first notification bulletin and take the appropriate immediate action to identify suspect switches. If you are not the end customer for this product and have subsequently shipped this product to a 3rd party, Eaton Corporation requests that you immediately forward this notice to the 3rd party.

There is the possibility that over time, the operating mechanism could wear in such a way that the switch will no longer function as intended and has the potential of being jammed in the “On” or “Closed” position. The potential also exists that the safety switch handle may indicate it is in the “OFF” position while the internal switch is still closed. Either of these could result in a potentially unsafe condition.

In order to remedy this potential condition, Eaton Corporation will provide you with a replacement switch at no cost.

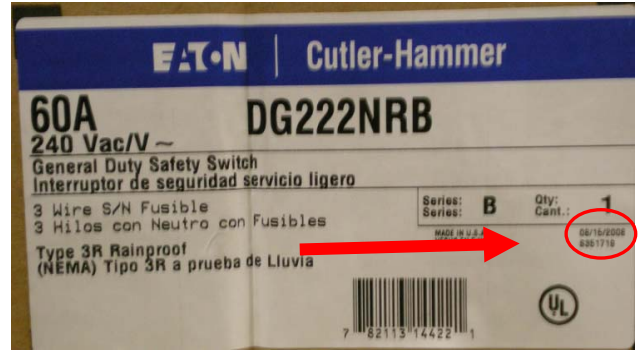
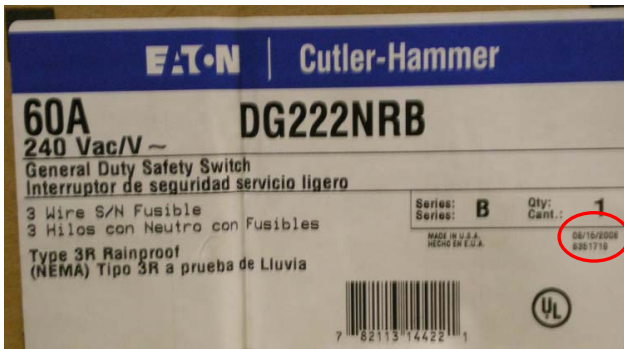
Figure 2: The red circles indicate where the package label date code is located.

The General Duty “B” Series Safety Switches that were shipped to you with this potential issue were manufactured between 9/17/2009 and 10/12/2009. The date codes for the unit or units in your possession are identified on the labels as shown in Figure 2 and in Figure 3. The date code is located on both the packaging label of the box and on the inside of door of the switch. A list of Suspect Catalog Numbers and the impacted dates for those can be found in Appendix B.

noted in Appendix B. Again, the date code can be identified from the carton label (shown in Figure 2) or from the inside door of the unit (shown in Figure 3). If the date code is between or inclusive of the dates shown in Appendix B, then you have a potentially suspect switch in which Eaton Corporation will replace.
